Trockenlaufende MR in Konustrockner

Dry running mechanical seal in a conical dryer

Information **ED09052**

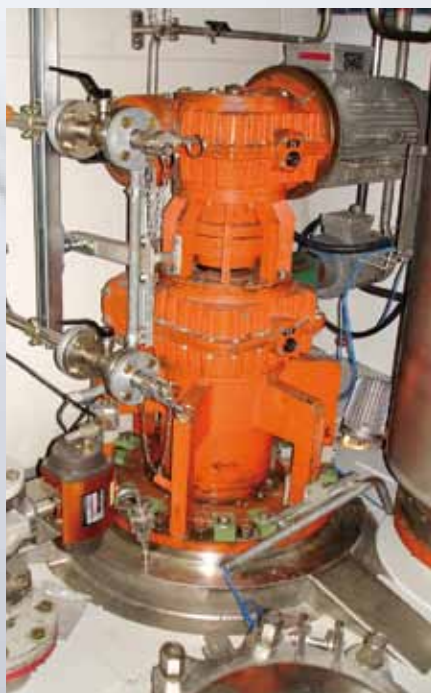
Apparat mit Dichtung und Versorgungssystem

Apparat: Konustrockner mit Obenantrieb Typ Vrieco-Nauta
Hersteller: Hosokawa Micron
Dichtungen inkl. Werkstoffe: MR5S2T/380-E1, B4Q2KGG (1.4571)
Fahrweise: trocken laufend mit Stickstoff-Quench

2004 wurden deshalb die Lippendichtungen ersetzt durch eine einfachwirkende Gleitringdichtung vom Typ MR5S2T. Um einen Umbau des Trockners zu vermeiden, wurde die Gleitringdichtung an den vorhandenen Einbauraum angepasst. Da die Dichtung innerhalb des Apparates liegt, aber keine Schmierung durch das Produkt möglich ist, wurde eine trocken laufende Gleitringdichtung ausgewählt.

Diese wird wie zuvor die Lippendichtung mit Stickstoff gequenchet. Die Verbrauchsmenge an Stickstoff konnte im Vergleich zur Lippendichtung deutlich gesenkt werden.

Die Gleitringdichtung ist außerdem so ausgelegt, dass gewisse Taumelbewegungen der Welle toleriert werden und damit keine negativen Auswirkungen auf die Lebensdauer der Dichtung haben.

Mit dem Austausch der Lippendichtungen durch eine Gleitringdichtung konnte die Lebensdauer der Dichtung und damit die Verfügbarkeit der Anlage signifikant erhöht werden. Seit 2004 ist die Dichtung bisher kein einziges Mal ausgefallen. Damit konnten die Instandhaltungskosten, aber auch die Betriebskosten durch die geringeren Stickstoff-Mengen deutlich reduziert werden.
